PLOCAN CAMPAIGN REPORT (ADF19/1222)

Call identifier: H2020-BG-2018-2020
Topic: BG-07-2019-2020
Grant Agreement No: 101000858
Dissemination level: Public
Date: 29.04.2024

The EU-funded TechOceanS project has developed and demonstrated through several underwater vehicles nine pioneering technologies for ocean biology, chemistry and plastics monitoring. The novel solutions comprise five sensors, two imaging systems targeting seabed and pelagic biology and plastics, a sampler that will collect particle samples and a new AI-based image processing method for data compression and information transmission.

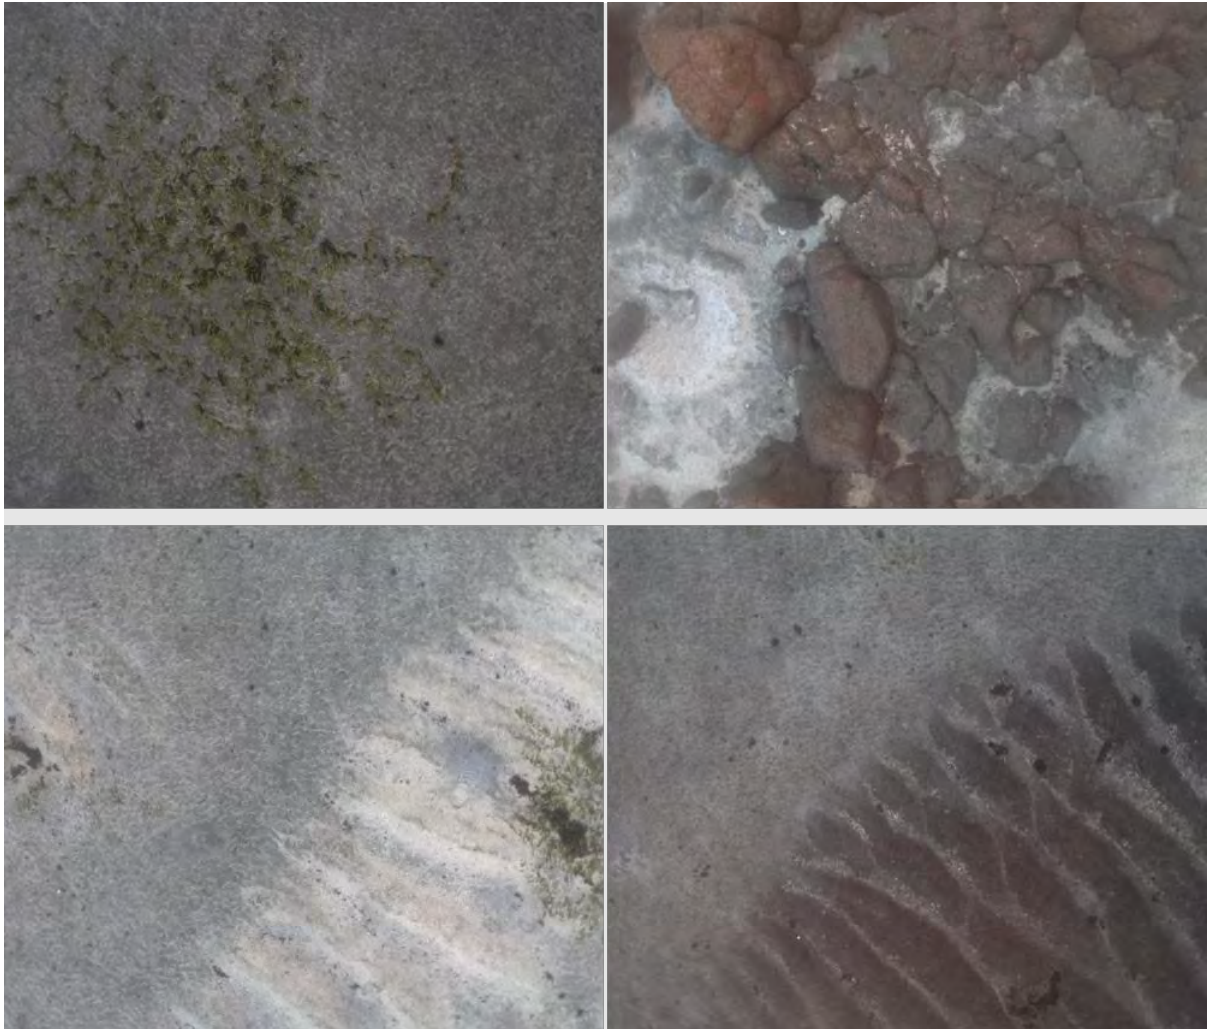
Figure 2.16: Examples of post-processed full resolution images showing volcanic rock, sand ripples, transition between hard substrate and sand, and probably sea grass acquired from 5m altitude.

- ALR team visited Puerto Rico harbour to finalise planning for recovery.
- Work underway to review and process the BioCam imagery taken with ALR3. Below are a couple of example images taken at approximately 5m altitude on Saturday afternoon.

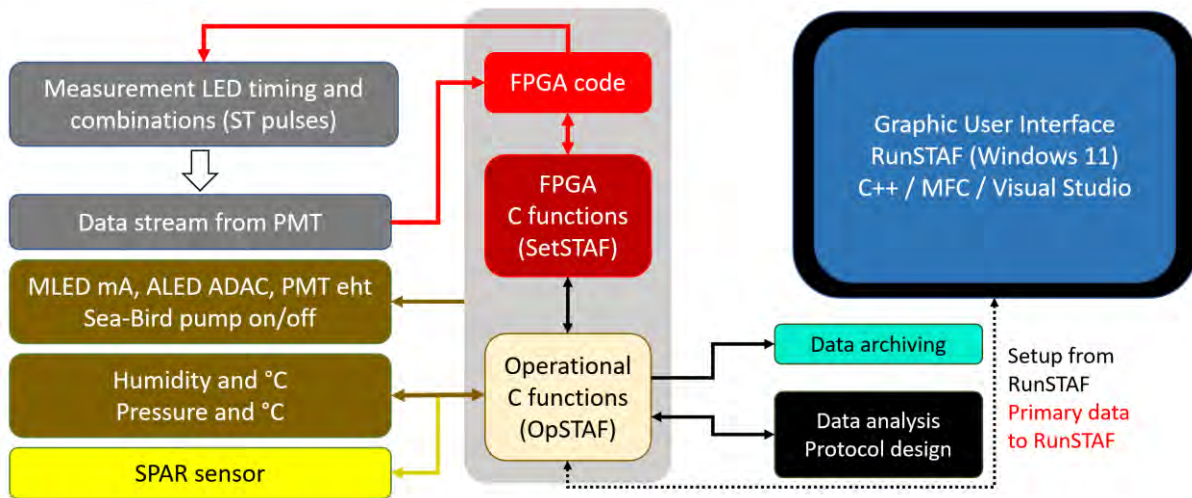
Figure 4.1.1: Overview of the firmware and software package for MicroSTAF

Figure below provides an overview of the firmware and software package for MicroSTAF, as outlined within the design specification. At the start of the PLOCAN trial, the FPGA and SetSTAF elements were still going through testing. The MicroSTAF version of RunSTAF (hereafter RunMSTAF) had largely been developed without access to a complete set of MicroSTAF electronics and was going through a phase of integration with the embedded SetSTAF code. The OpSTAF element provides a pass through to the SetSTAF functions, to allow RunMSTAF to set all FPGA functions. During the tests, it also allowed the pump to be turned on and off and the humidity and pressure sensors to be read.

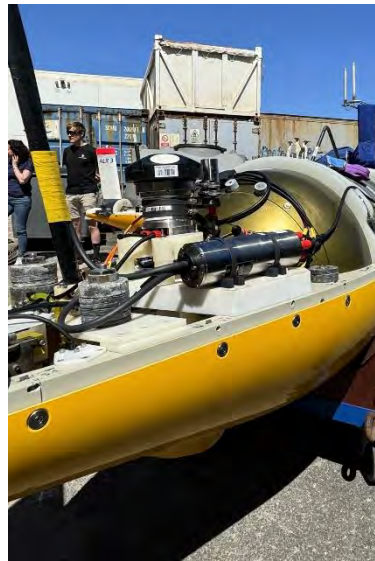
Figure 4.1.2: View of the MicroSTAF integrated in the ALR.

Mechanical integration of MicroSTAF within ALR5 was straightforward and allow for simple exchange of the unit used for ballasting at NOCS before shipping to PLOCAN and the working unit shipped separately to PLOCAN during the first week of March. At the time, the MicroSTAF unit required 1.6 A at 12 V to get over the inrush phase, before dropping to between 160 and 200 mA at 12 V. The ALR5 could only provide 1 A at 12 V and, as a result, could not power up the MicroSTAF unit. After working through the limited options, it was decided to reinstall the original non-working unit that had been used for ballasting.

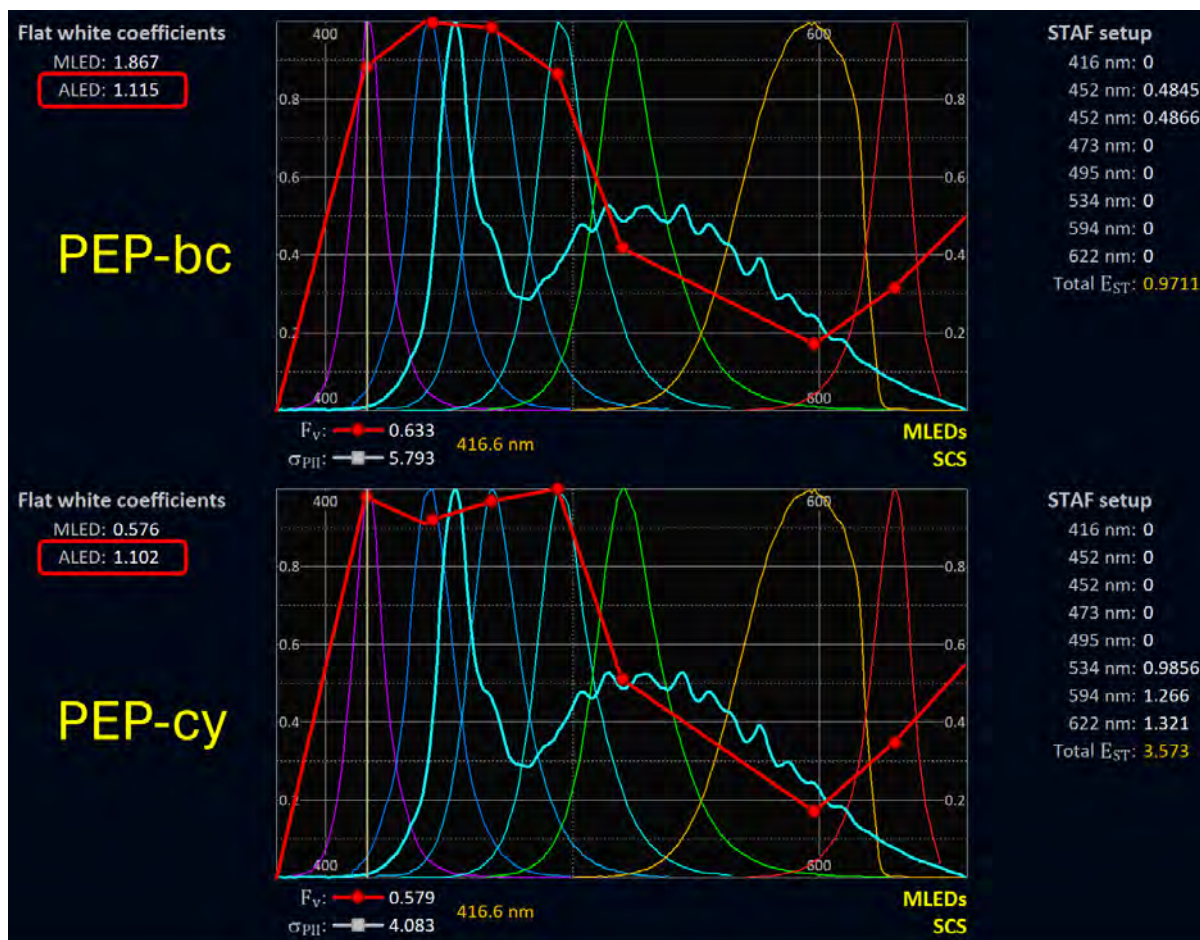
Figure 4.1.3: Comparison of PEP-bc and PEP-cy from a sample collected from 15 m depth at Site 1 (site defined by Julie Robidart) on 12th March 2024.

Figure below shows an example of the difference between PEP-bc and PEP-cy from the same sample. The ALED flat white coefficient has a proportional impact on the calculation of PSII photochemical flux (J_{PII} and JV_{PII}). In this example, the difference is around 12% (higher for the PEP-bc). This is at the high end of the difference observed across all samples. Figure below shows the FLC generated with the PEP-bc.

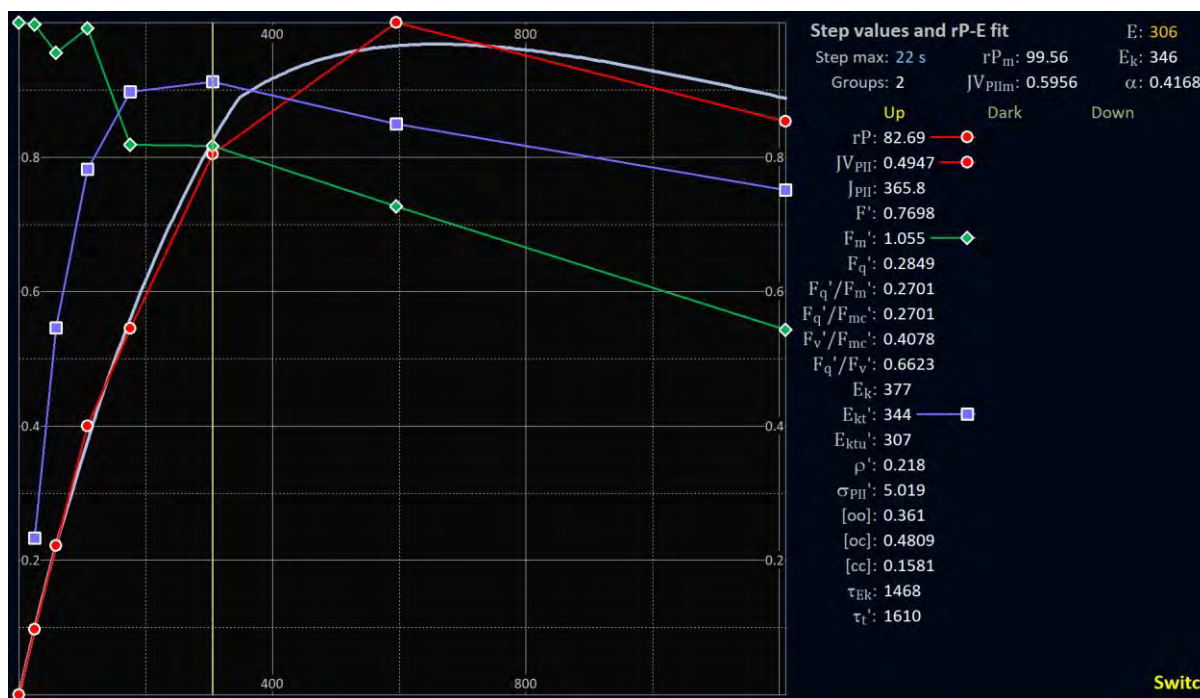
Figure 4.1.4: FLC generated by sample collected from 15 m depth at Site 1 (site defined by Julie

Robidart) on 12th March 2024. The MLEDs were as set for PEP-bc in Figure 5.1 (both 452 nm channels).

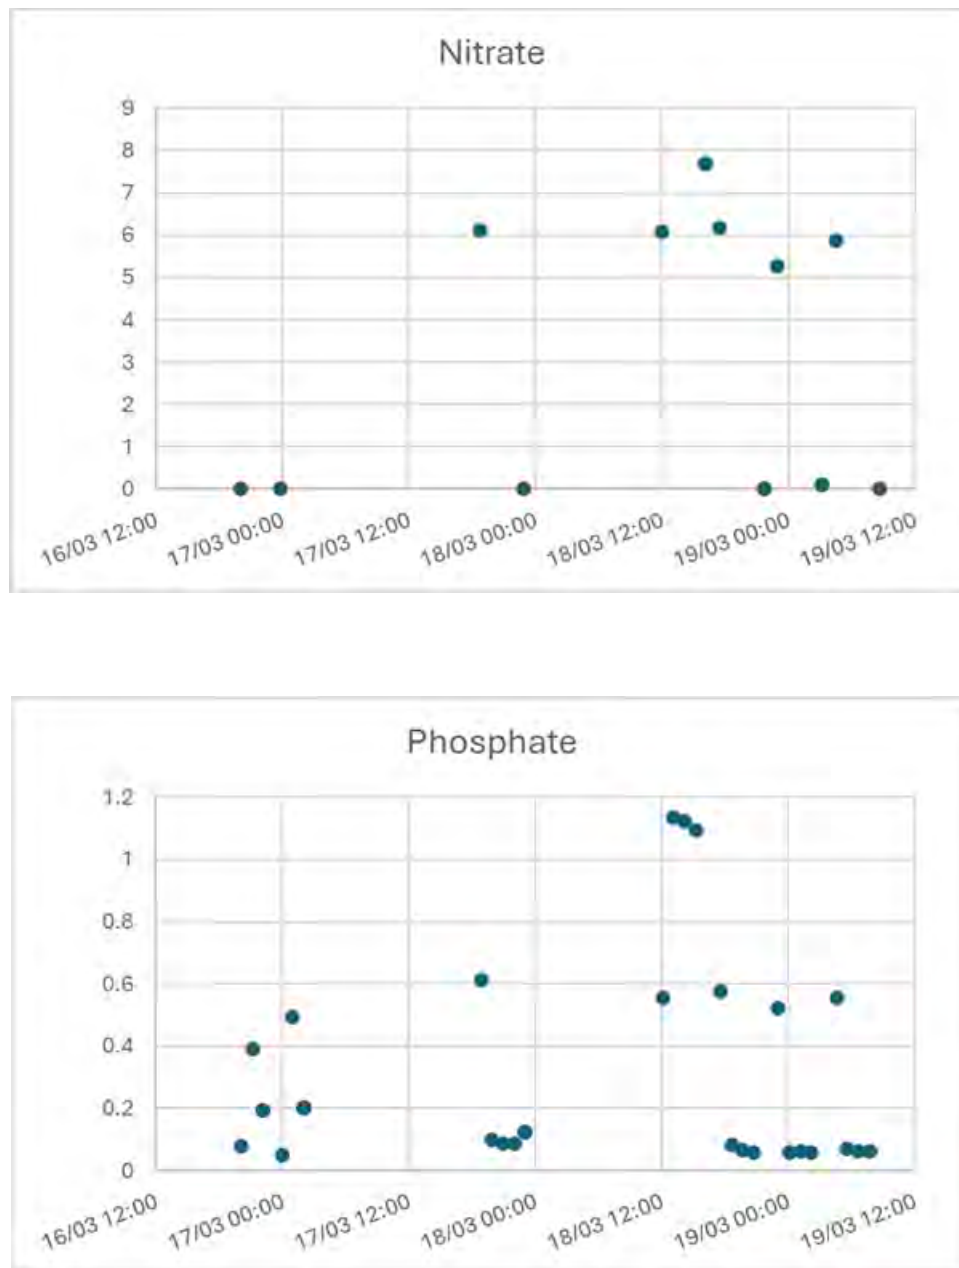
Figure 4.3.3: Examples of nitrate and phosphate data generated during extended ALR deployment. The vertical axis gives the concentration of the nutrient as reported by the sensor (in micromol / L)

Error! Reference source not found.4.3.3 shows some preliminary data obtained during one of the dives during the third (extended deployment) for the N/P sensor.

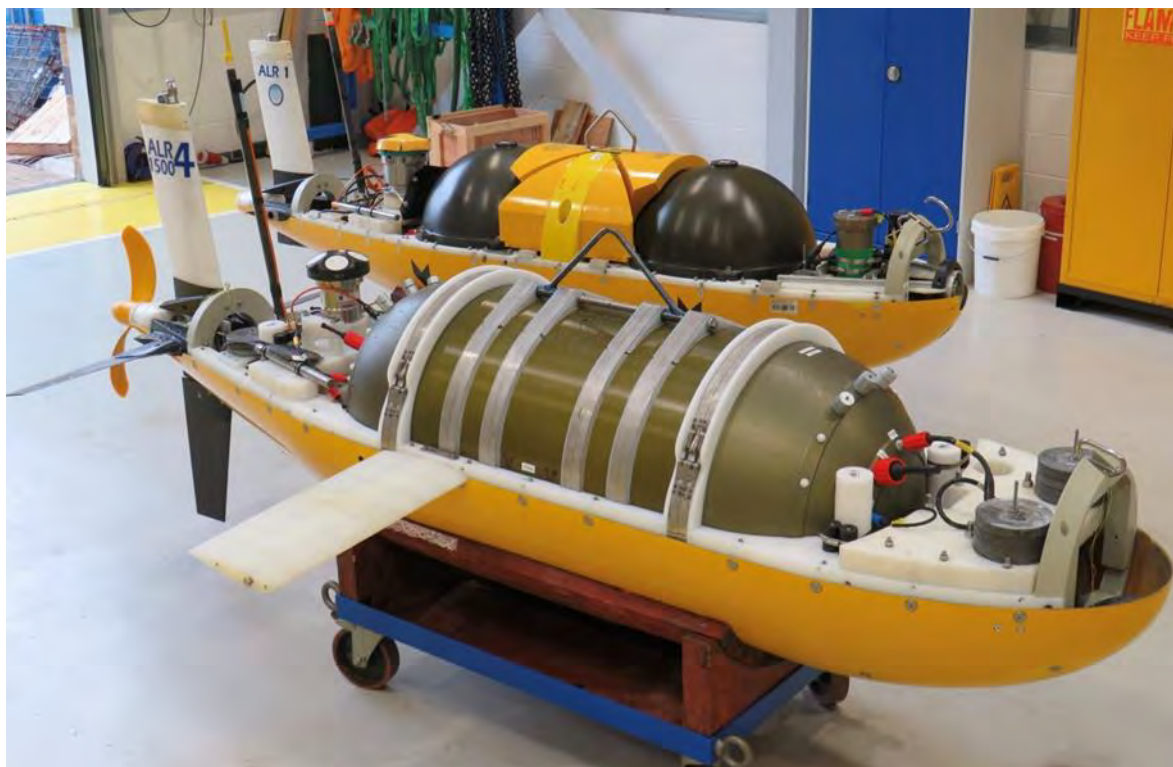
Figure 5.1: Autosub Long Range Variants, 6000m depth rated behind, 1500m in front

NOC currently operate six Autosub Long Range (ALR) vehicles three 1500m depth rated and three 6000m depth rated (see Figure 5.1). All the vehicles are 3.6m long, 0.9m diameters and displace 1.2m³ in water (see Figure 5.2). Each vehicle is equipped with a single thruster at the stern and three movable control surfaces: one rudder and two jointly actuated sternplanes completing the aft arrangement is a fixed vertical fin which houses secondary relocation beacons. For primary navigation the vehicles are equipped with a down DVL (Nortek 500 or RDI Workhorse 500), a MEMS compass and orientation sensor (PNI) and an acoustic modem for acoustic aided navigation. For further details see Roper et al. 2021 and Phillips et al. 2023.

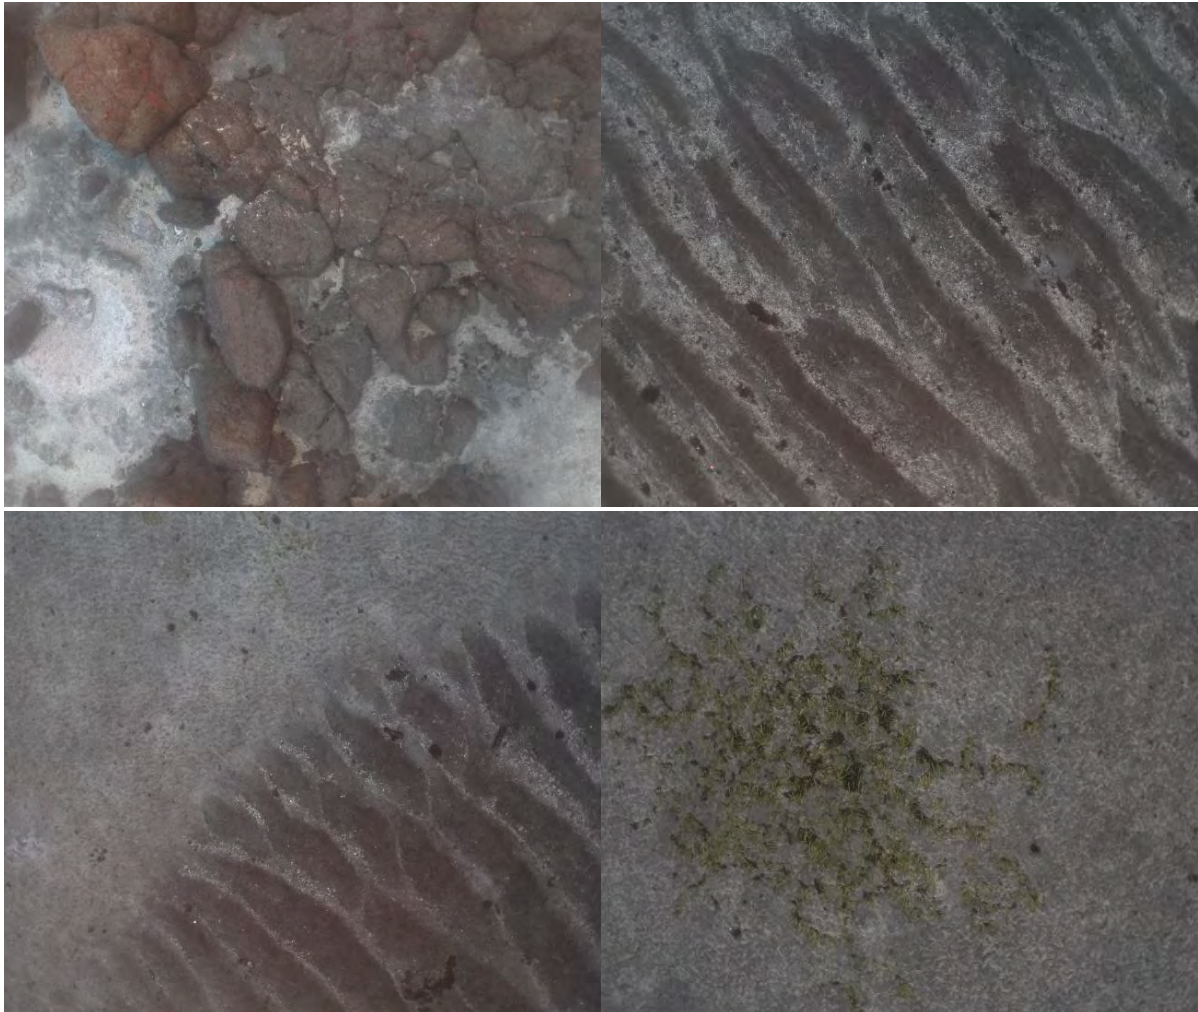
Figure 6.7.1: Examples of post-processed full resolution images showing volcanic rock, sand ripples, transition between hard substrate and sand, and probably sea grass acquired from 5m altitude.

5m. Figure 6.7.1 shows a few full resolution images that were colour and attenuation corrected after recovering the AUV. Due to the lower mapping altitude and so shorter distance the light travelled, the colours are more vivid than those acquired during the "ALR3 Calibration Missions Take 2 and Initial BioCam Survey" mission. Due to operational issues it was not possible to run the near real-time remote awareness pipeline. However, all data had been successfully recorded and all processes can be run in post-processing.
